CASE STUDY

REINLAND DRAIN

Channel Stabilization
Winkler, Manitoba

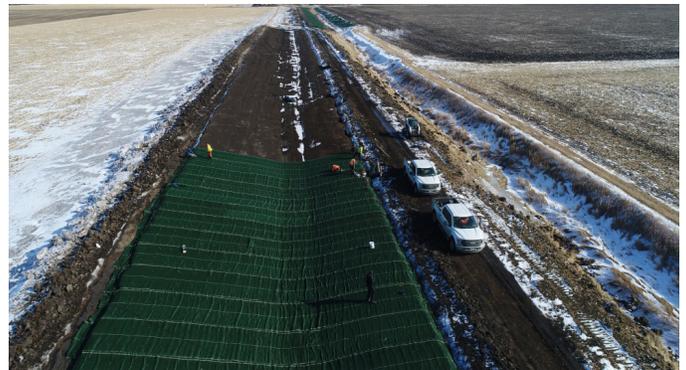
PROBLEM

Years of erosion, combined with damage from significant flooding, caused major failures to the Reinland Drain

The Reinland Drain is a municipal drainage channel in Manitoba that receives flows from the entire Pembina Valley. The channel's sandy, silty clay soil could not handle flow from a 100-year storm event. Years of erosion, combined with damage from significant flooding, caused major failures to three kilometers of the channel. The town needed to stabilize the eroded channel banks to prevent further flooding and shoreline loss.
