# RESILENT FLOOD MITGATION

# **Oyster Lake Outfall Improvement**

#### CASE STUDY Murrieta Creek Stabilization

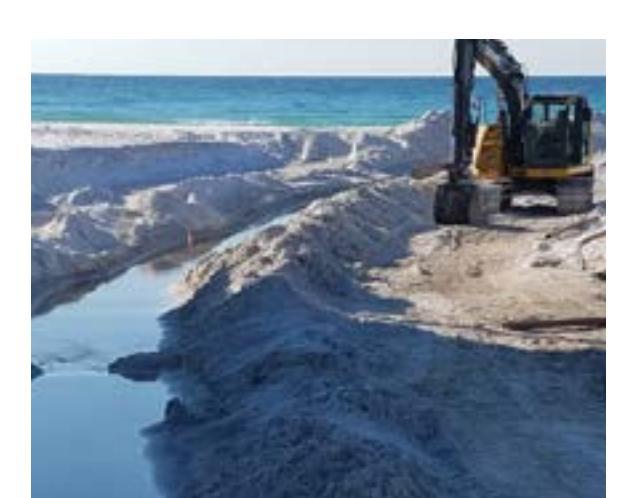
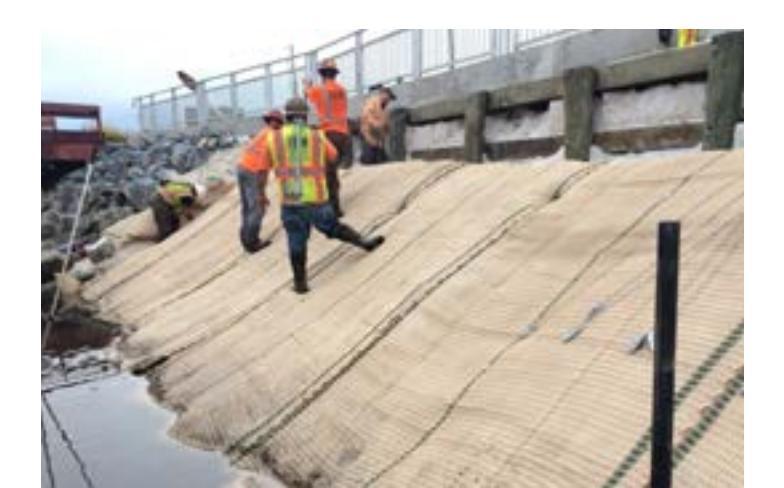
More than 2,000 square yards of ARMORMAX, consisting of High Performance Turf Reinforcement Mat (HPTRM) and Engineered Earth Anchors (EEA), was installed along the channel. This system was selected because it provides slope stabilization and erosion control while promoting vegetation. During installation, 2,000 sea oats were planted within the HPTRM, which is designed to promote vegetation.

After installation, Hurricane Michael (category 4) made landfall 60 miles east of Oyster Lake causing winds up to 80 mph, storm surge, and significant rainfall and flooding at the project location. The vegetated slopes of the outfall withstood the extreme conditions, protecting beachfront homes, nearby businesses, underground utilities, a section of Highway 30A, and a bridge that crosses the channel.

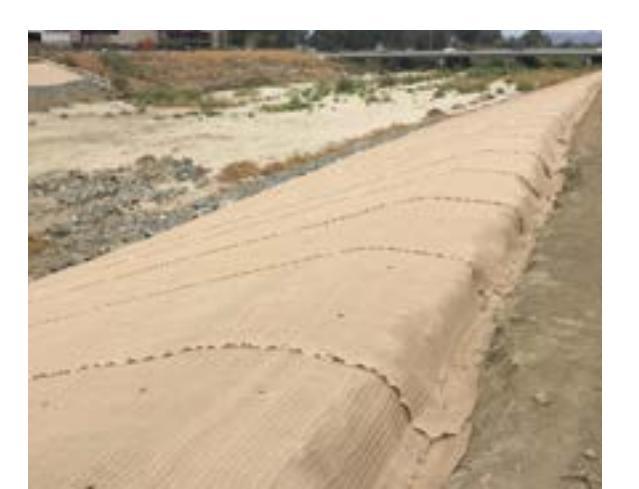
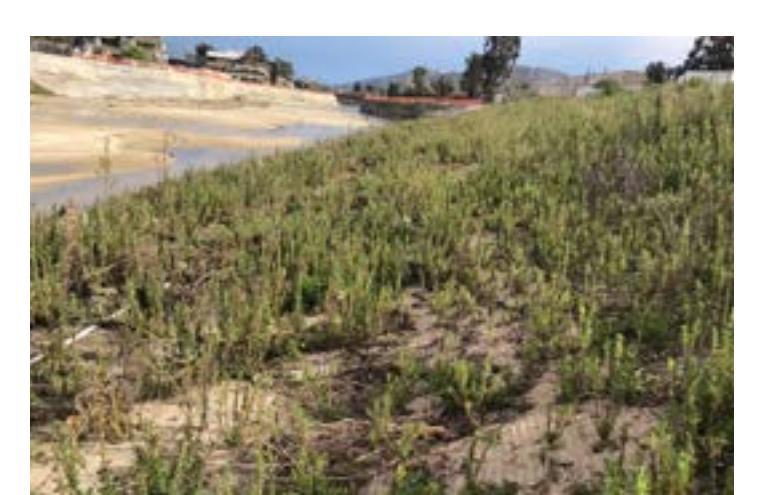
In 2000, the U.S. Army Corps of Engineers initiated the Murrieta Creek Flood Control, Environmental Restoration and Recreation Project to mitigate flooding. In phase two of the project, ARMORMAX was selected to provide erosion and scour protection on the creek banks. The system consists of High Performance Turf Reinforcement Mat (HPTRM) and earth anchors that provide resilient flood control for up to 75 years.

Vegetation was quickly established, and ARMORMAX has effectively protected the channel from erosion and flooding.

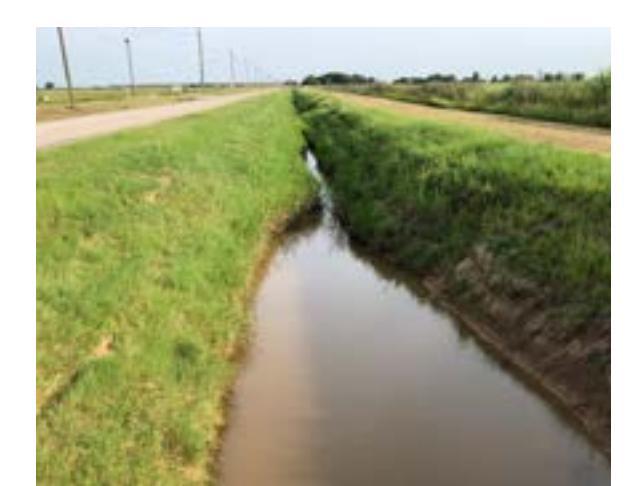
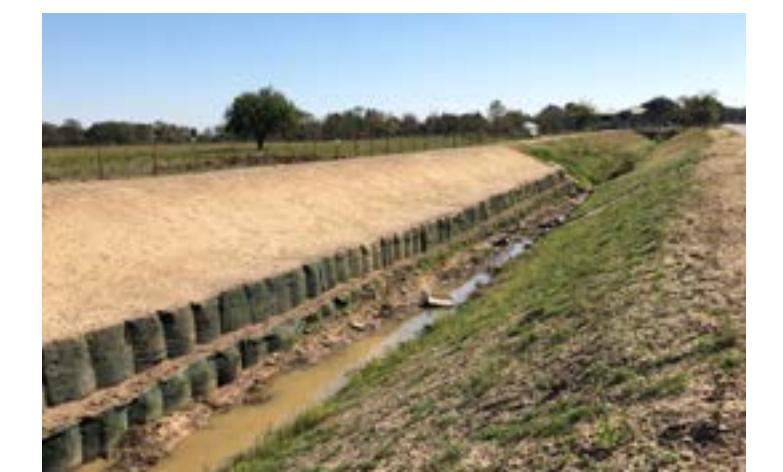
Stakeholders selected SCOURLOK for the remaining phases of the project because it was a more cost-effective solution. SCOURLOK is a stabilization system that features rigid and interlocking cells armored with erosion protection from a highly UV stabilized High Performance Turf Reinforcement Mat (HPTRM). The system is engineered to provide a vegetated, gravity wall system that resists sliding and overturning for up to 75 years.

The design included an eight-foot wall, comprised of two tiers of SCOURLOK that spans 500 feet along the eastern side of the channel. The design also included 300 square yards of ARMORMAX along the top of the channel.

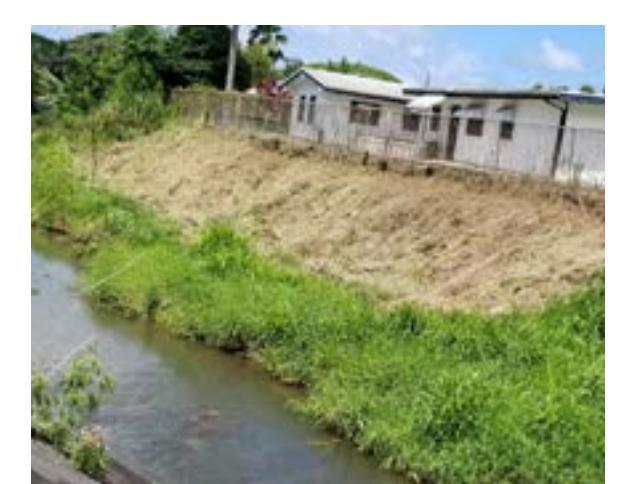
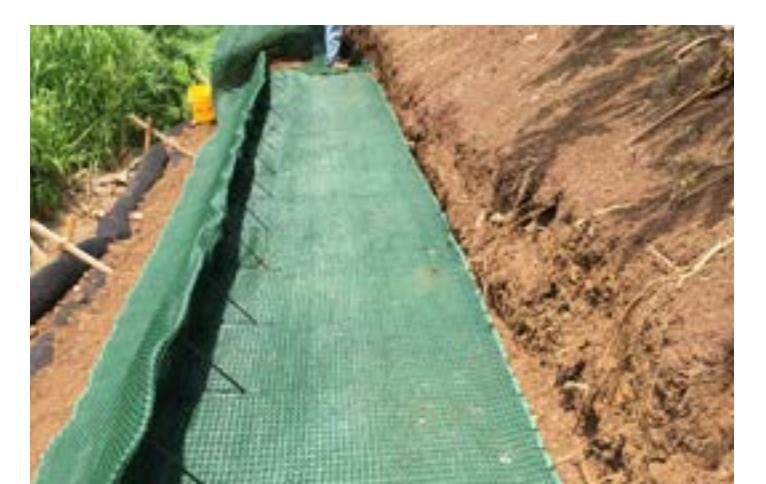
PYRAWALL engineered wrap-faced vegetated solution, was selected to reinforce 330 feet of Kaneohe Stream. The installation ranged from six to eight feet high and was designed based on geotechnical information available at the site. This included steep 1H:4V slope segments with a mid-slope planting bench.

PYRAWALL combines High Performance Turf Reinforcement Mat (HPTRM) with internal braces to reinforce soil mass and resist lateral earth pressures. It is also designed to encourage vegetation and is a vegetated Best Management Practice Solution for NPDES Storm Water Compliance. This wall system is comprised entirely of three engineered geosynthetic components with no metal, concrete or short-lived biodegradable materials.

The vegetated wrap-face wall system provided resilient bank reconstruction and stabilization along a residential section of the Kaneohe Stream that will provide flood mitigation for up to 75 years.
